Appendix 11.1 Peat Slide Hazard and Risk Assessment

1 Introduction

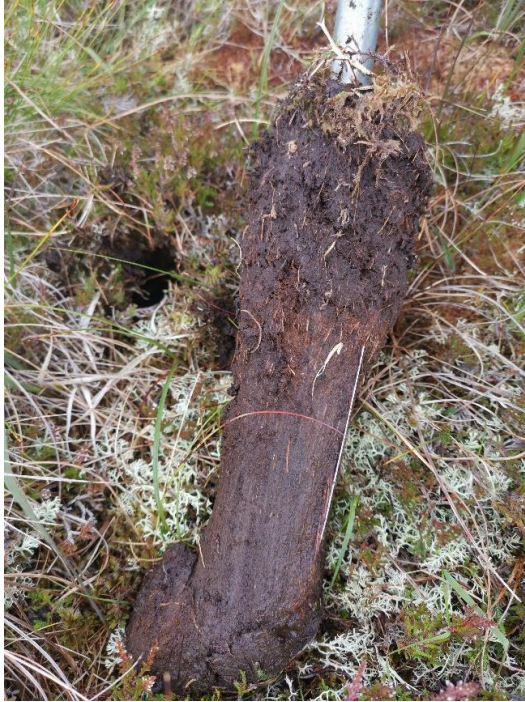
Photograph 1 – Auger from T1

5.7 Peat sampling was undertaken using a hand auger, at proposed turbine and infrastructure locations. Samples retrieved from hand augering were examined to provide additional information and understanding of the nature of peat at varying depths and locations. Selected peat samples, from locations where peat depth greater than 0.5 m was recorded, were dispatched to Envirolab laboratory and tested for moisture content, bulk density, and carbon content. Table 1 provides information on the location and depth of peat samples tested, and a selection of photographs is provided below Table 1 to show the nature of peat and peaty soils extracted by hand auger at these locations. The laboratory testing report is provided as Annex 2.

Reference	Location	Easting	Northing	Depth (m below ground)	Notes
469	T1	329095	994396	0.5	Fibrous in upper part only, possible acrotelm/catotelm boundary
358	T2	328746	993899	0.5	Medium brown, somewhat fibrous
359	T3	328341	993650	1.0	Medium brown, somewhat fibrous
470	T4	327865	993632	1.0	Brown, somewhat partly fibrous
453	Borrow pit search area	329292	994610	0.5	Medium brown, somewhat fibrous

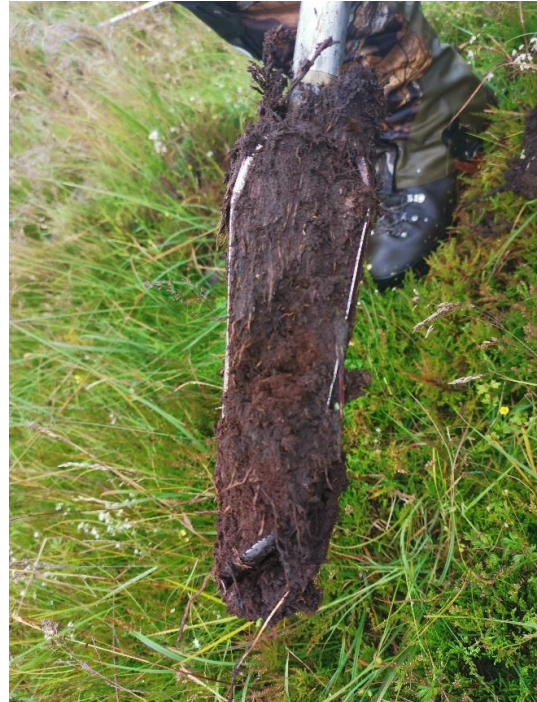
Photograph 2 – Auger from T2

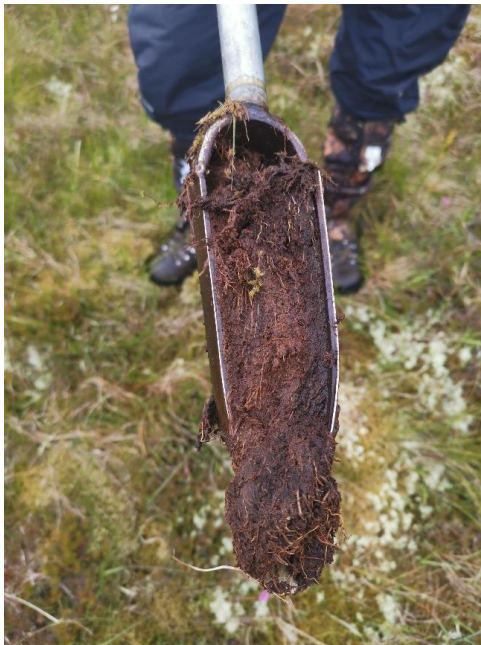
Photograph 3 – Auger from T3

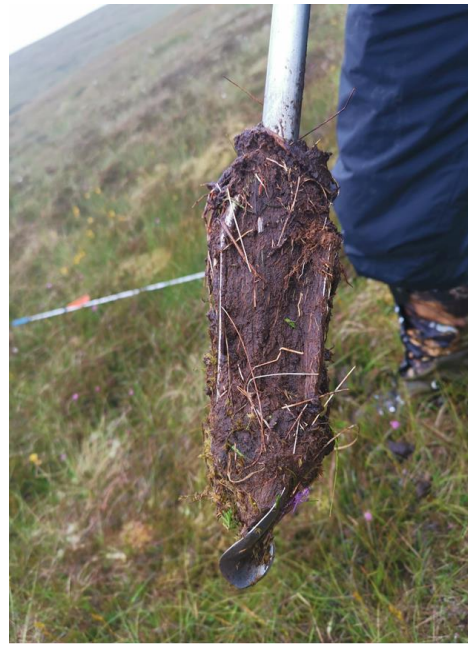
Photograph 4 – Auger from T4
