Orkney's Community Wind Farm Project: Hoy

**EIA Report Appendix 11.2 Figure 1  
Onsite Peatland Restoration Areas**

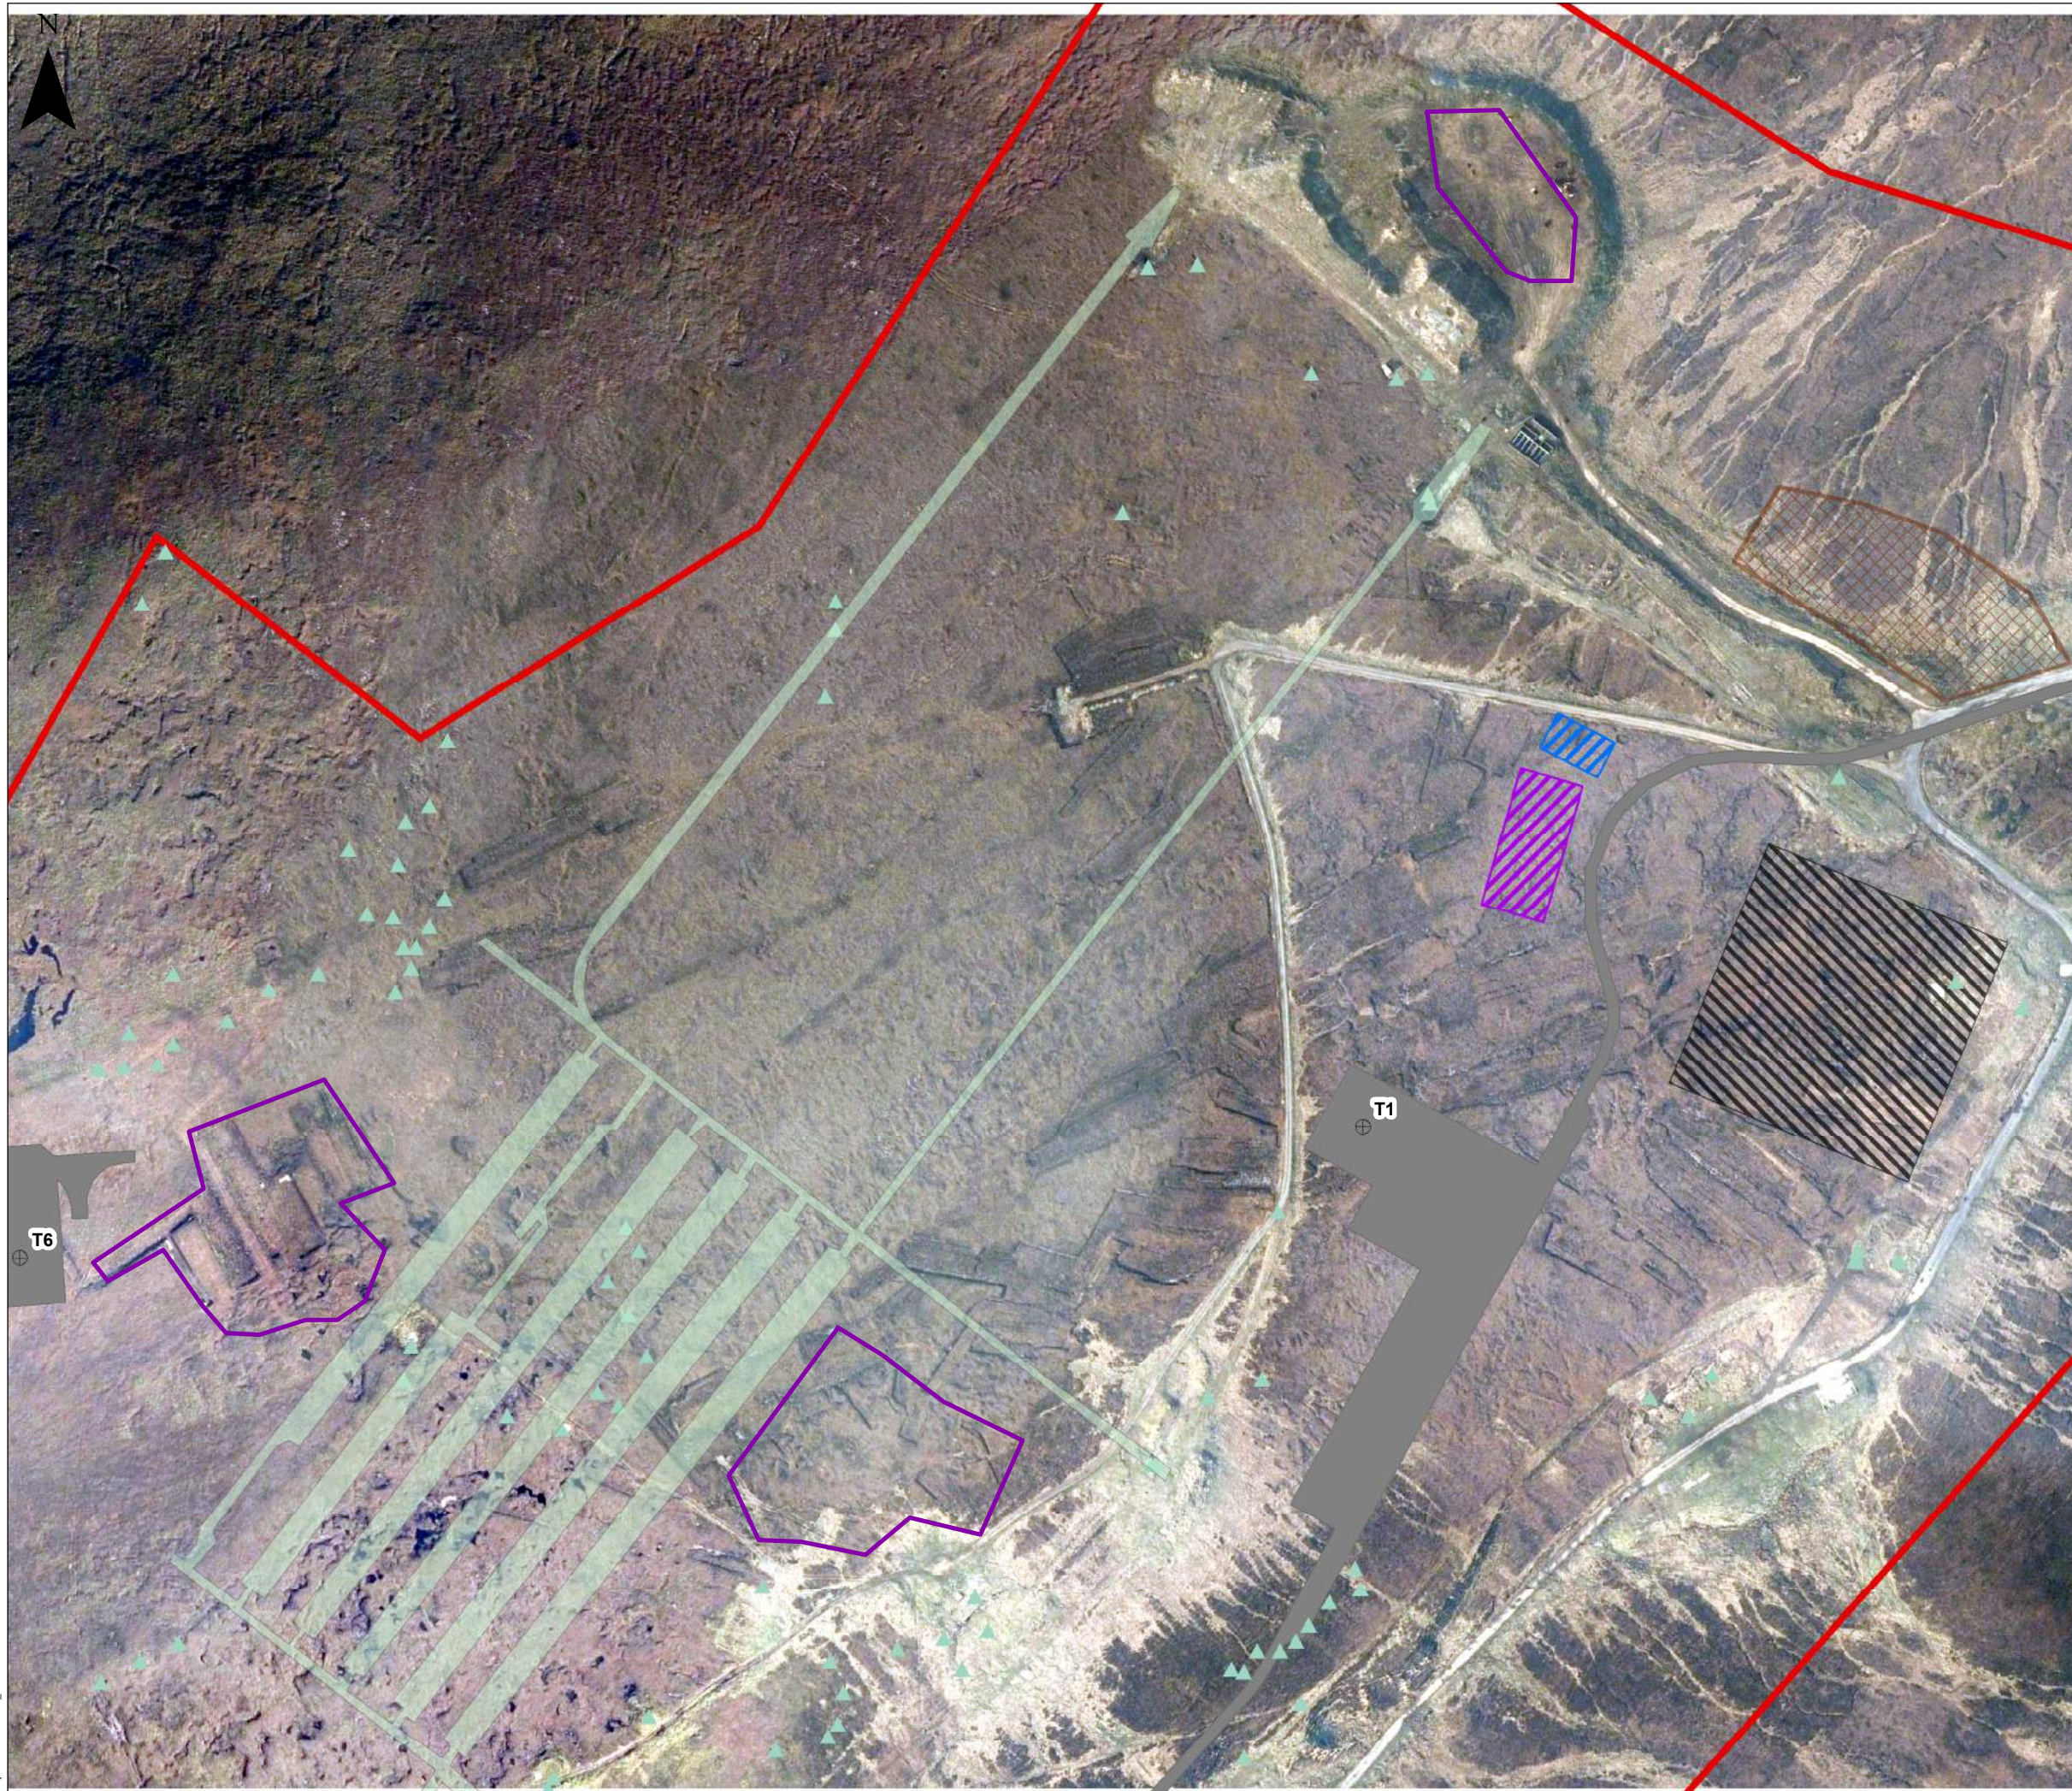
Proposed onsite restoration areas avoid slopes of >6 degrees and identified on-site heritage assets.
